MAHBULLETIN

Lessons Learned Bulletin No. 6 CHEMICAL ACCIDENT PREVENTION & PREPAREDNESS

Natech Accidents

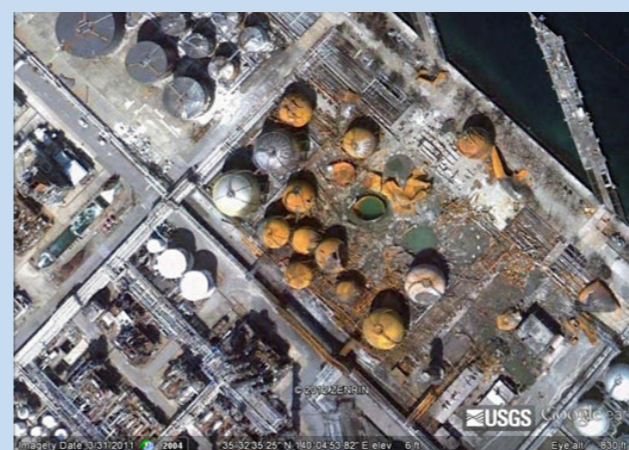
During a severe earthquake that hit a large chemicals facility, acrylonitrile was released to the atmosphere from a failed tank roof, and into containment dikes from two other tanks which suffered pipe breaking at the tank base. A significant amount of acrylonitrile overflowed the containment dikes and was lost in the ocean through the drainage channel as surface runoff. With the concrete containment dikes having been cracked by the earthquake, a considerable amount of substance leaked into the soil and reached the coastal aquifer below the site.

Figure 4: The LPG tank farm at the Chiba refinery after the earthquake-triggered fires and explosions (2012 Google, ZENRIN)

- In natural hazard prone areas an installation's emergency plan needs to consider the risks of natural hazard impact. This includes the preparation of stand-alone emergency plans that do not rely on the availability of offsite utilities and response resources.

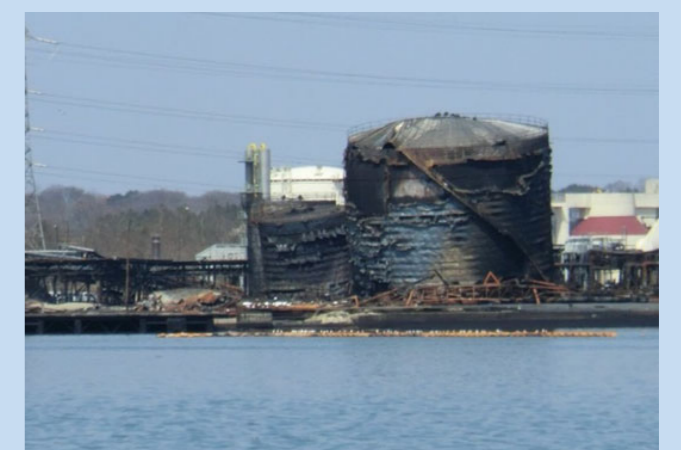
A major tsunami caused multiple pipe breaks and many small hydrocarbon spills from pipe connections when it hit a refinery located at the coast. The releases ignited, causing a major fire that involved three tanks filled with sulphur, asphalt and gasoline, and which destroyed a significant part of the refinery.

Figure 5: Burned tanks at the Sendai refinery hit by the tsunami (Photo Credit: C. Scawthorn)

- Where land-use planning restrictions are difficult to implement for existing installations, supplementary prevention and preparedness measures are required to protect hazardous facilities from tsunami impact.

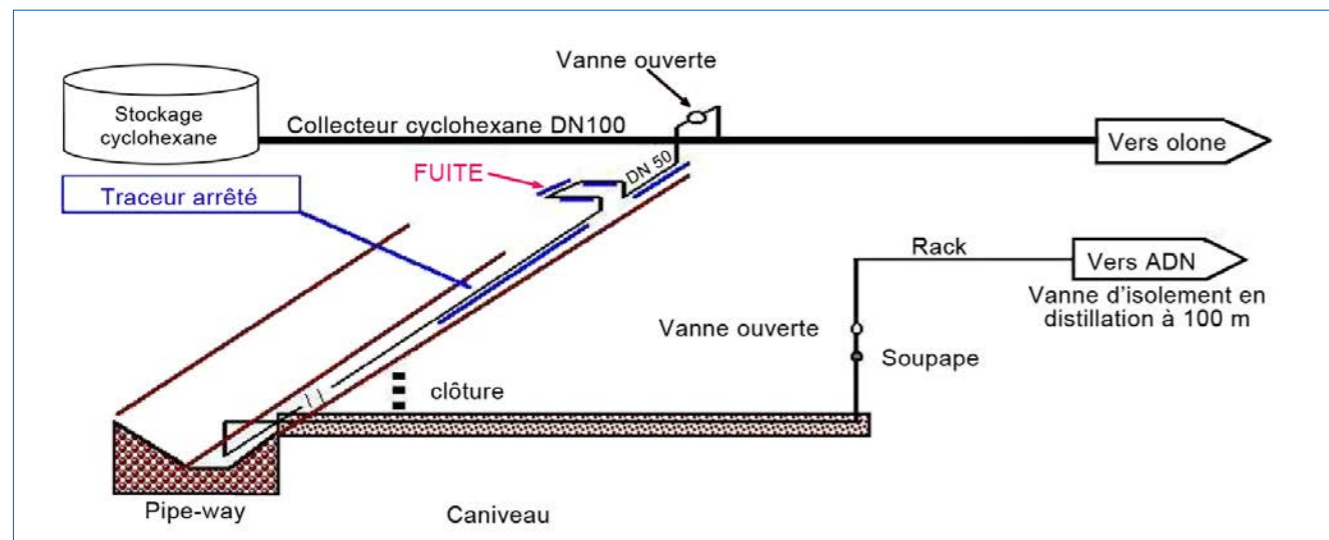
The temperature varied greatly over the weekend of mid-December. Lacking a functional temperature control, the varying temperature in the pipe caused the cyclohexane to expand and contract. A malfunction of the pipe heating device ($T < 6.5^{\circ}\text{C}$) led to the formation of the blockages in the pipe canal. Ultimately, the DN 50 mm branch pipe ruptured at the expansion loop, creating a hole about the size of the palm of one's hand. The expansion loop was the part most exposed to the changes in temperature because of its shape and position up above the pipe-way, (the trench holding the pipework)(see Figure 3).

- In early December 2002, freezing temperatures caused the cyclohexane to solidify in the manifold. The large variation in the temperature caused an expansion/contraction of the cyclohexane which contributed to the rupture of the pipe.
- The DN50 mm manifold was permanently open even in the event of non-use and only the adiponitrile (ADN) production unit admission valve was closed.
- The location of the released cyclohexane was found by its odour, indicating that no monitoring technology had been implemented on the pipe.

Figure 3: The affected process (Source: ARIA No. 23839)

- Operators must be aware of the physical characteristics of the dangerous substances, on site such as their tendency to solidify in extreme cold temperature. These factors should be included in the HAZOP or other hazard identification studies for the affected chemical process (See also Chemie Pack accident at http://www.onderzoeksraad.nl/uploads/items-docs/1805/Rapport_Chemie-Pack_EN_def.pdf). Also, where significant variations of outside temperature can be expected, operators should identify possible hazards that might be triggered.
- The cyclohexane spilled was revealed by its odour. Relying on odour alone for detection is not a recommended practice on sites where large volumes of dangerous substances are stored. Proper detection in case of release of dangerous substance is crucial to enable staff to act immediately in case of an emergency.

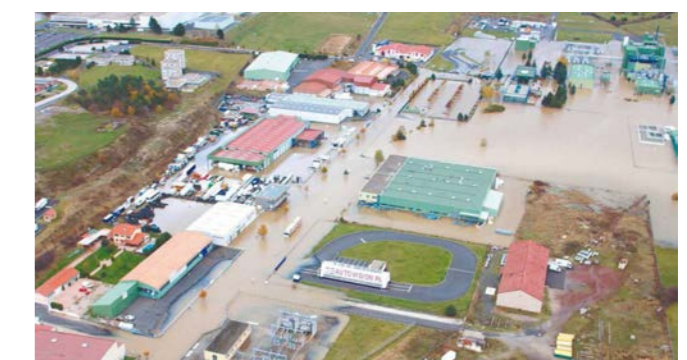
Figure 2: The affected site (Source: ARIA No. 35426)

The torrential rains during the previous days resulted in the flooding of the site. The zone was not located in an easily flooded zone but since the site was located in a natural depression, it was flooded even though the platform was raised from 0.8 to 1.5 metres at the time of construction of the site. The flood occurred due to insufficient draining of the water from the catchment area housing the industrial zone given the torrential downpour over a short span.

- The zone was not classified as flood-prone zone, even though less intense showers had been experienced five years before the incident. The water level then had reached 662.2 meters (site platform stood at 662.5 meters), whereas on the date of the event the water reached a level of 663 metres.

- Flooding can occur even in a zone that is not classified as flood-prone; therefore, early warning is crucial to put together the crisis management units and organise all rescue operations.
- There was significant damage to some equipment. Hence, it is important to prevent crucial instruments or laboratory equipment from coming into contact with water. In addition, chemicals that violently react with water should be stored at a height above the maximum water level for all flooding scenarios or be protected by dams.
- Operators should be prepared for a possible inundation of the plant in case of heavy rainfall. There should be a deliberate effort to maintain awareness of historic extremes of flooding in and around a site. Even areas that are not labelled as flood-prone can become inundated when rainfall is extremely heavy.
