Lessons Learned Bulletin No. 2 Major accidents involving contractors

Number 2
Dec 2012

Major accidents involving contractors

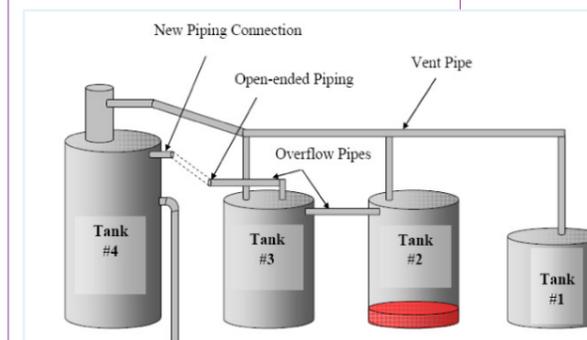
The incident occurred when contract workers were installing a new pipe connection from two storage tanks to a third storage tank (see image below). Welding sparks ignited flammable vapour escaping from an open-ended pipe about four feet (1.21 m) away from the contractors' welding activity on a fourth storage tank nearby. The explosion killed three workers and seriously injured a fourth one.

Tanks involved in the incident

Contractors were instructed to weld a pipe between two storage tanks (Tanks 3 and 4). To prepare for the welding operation, they removed the hatch at the base of Tank 4 and entered the tank to remove the crude oil residue. Then they flushed the tank with fresh water and allowed hydrocarbon vapour to evaporate for several days. They did not clean out or purge Tanks 2 or 3. On the day of the accident, one worker inserted a lit oxy-acetylene welding torch into the hatch

and then into the open nozzle on the opposite side of the tank to verify that all flammable vapour had been removed before welding, which is clearly an unsafe practice. The workers laid a ladder on the tank roof, extending it across the 4 feet (1.21 m) space between the two tanks (Tanks 3 and 4). Almost immediately after the welding operation began, flammable hydrocarbon vapour venting from the open-ended pipe attached to the adjacent tank (Tank 3) ignited. The fire, which immediately flashed back into Tank 3, spread through the overflow connecting pipe from Tank 3 to Tank 2 which then exploded. The lids of both tanks were blown off.

- The open pipe on the adjacent tank was not capped or otherwise isolated.
- A makeshift work platform—a ladder placed between the tanks—was used.
- All tanks were interconnected and some of the tanks contained flammable residue and crude oil.

- When two or more oil tanks are linked to each other, the connection pipes should be equipped with isolation valves to prevent the escape of flammable vapour.
- The company should develop and implement written procedures and provide contractor training to ensure safe work practices during hot work, tank cleaning and work at elevated locations. These measures would have assisted workers in identifying and eliminating hazards prior to beginning the welding operation.
