Lessons Learned Bulletin No. 8

Major accidents involving explosives

Number 8
December 2015
JRC99808

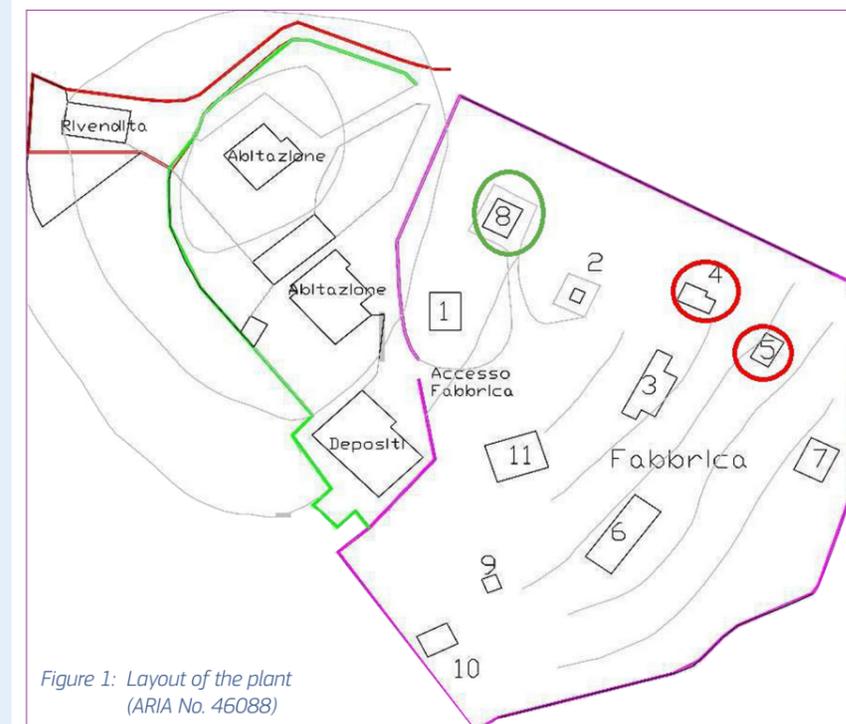
Figure 1: Layout of the plant (ARIA No. 46088)

A series of explosions occurred in the finished products storage area of a fireworks factory. The initial three explosions in short succession presumably occurred in the vicinity of sheds No 4 and 5 (Figure 1), which were used to store finished products (fireworks). Forty minutes after the first three detonations a fourth explosion occurred in explosives storage building No 8. At the time of the first series of explosions three workers, the operator and two technicians were transferring fireworks from the shed No

4 to shed No 5, using a small truck that was available for internal transfer. All of them died immediately in the first set of explosions. The fourth victim, the operator's son was killed in the fourth explosion while he was looking for his missing father.

A fire fighter was also hit by a projection triggered by the explosion of building No 8 and died in the hospital three months later. The successive explosions destroyed the factory and the blast waves caused serious damages in the buildings within a 500 m radius. The damage caused as a result was estimated to be more than 1.5 million Euros.

Based on the information collected by the inspection committee, it is assumed that the fireworks transfer operation was the trigger of the sequence of explosions. Ignition presumably occurred during the handling of the explosives.

- Furthermore, the inadequacy of the separation distances inside and outside the factory was discovered by government inspectors following the accident.

- Operating procedures deployed by the company were unsafe and prohibited by the regulations, given the fact that primed explosive products were found in the factory, that were unlawfully fitted with electric fuses. Failure to comply with the operational safety procedures and conform to national regulations is a clear sign of negligence. Conformance with norms and standards for handling explosives should be an ongoing subject of audits, inspections and training on explosives production and storage sites.

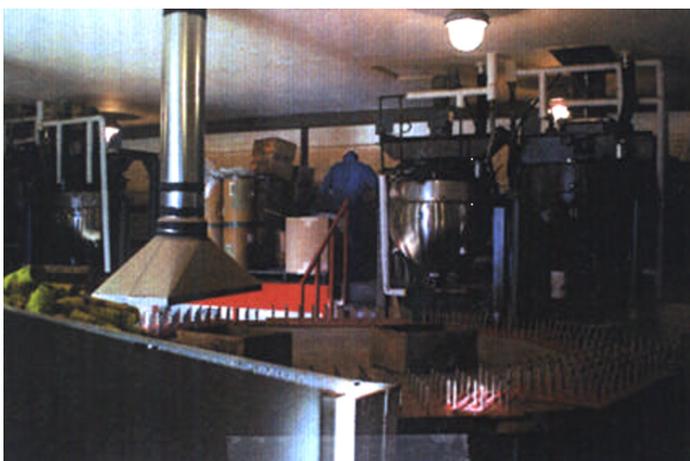
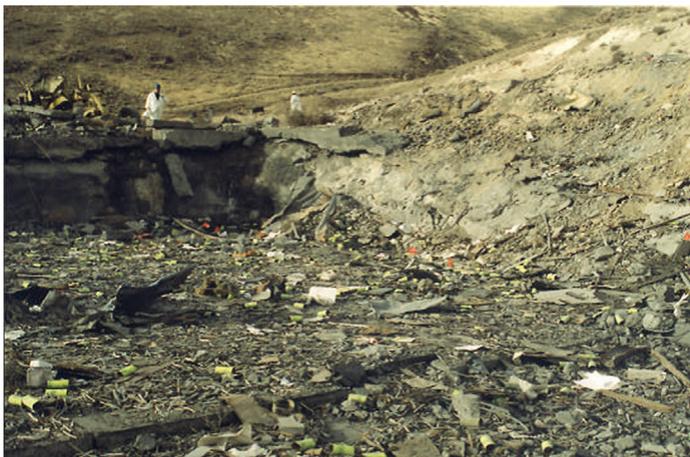
Figures 2 and 3: Booster Room 2 before and after the explosion (CSB)

Two massive explosions just seconds apart destroyed the Sierra Chemical Company's Kean Canyon explosives manufacturing plant in Nevada, killing four workers and injuring six others. Because everyone was killed, the exact cause of the accident could not be determined. However, it is thought that on the day before the incident, leftover base material was left in the mixing pot by an operator but this information was apparently not communicated to the next shift. The next morning the worker returned, and may have assumed that the pot had been emptied. Without checking its contents, the worker turned on the motor to the agitator blades, setting off the initial explosion. This explosion occurred in a room where workers made "boosters" - small explosive devices used in the mining industry to detonate larger explosives. A second, more powerful blast destroyed a building used for drying explosives, leaving a 40-by-60-foot (12 m x 18 m) crater that was up to six feet (1.8 m) deep. The explosions had the force of a magnitude 2.0 earthquake and were felt some 20 miles (32 km) away from the plant. Sierra Chemical estimated that in all, 47,000 pounds (21 t) of explosives were consumed during the accident. The facility was never rebuilt.

It is speculated that explosive material remained in a pot over night and due to the low outside temperature it solidified. The bottom of the mixer blade, which was embedded in the solidified explosives in the pot, detonated the explosives by impact, shearing, or friction of the explosive material with the pot wall. Another possibility is that chunks of explosive material were pinched between the mixer blade and the pot wall, causing the detonation.

- Process Hazard Analysis (PHA) was conducted for Booster Room 1 applying the same process as Booster Room 2. However, no PHA was conducted for Booster Room 2. Furthermore, supervisors and workers were not involved in the hazard identification activities.

- The storage facilities and the two workshops were closer to each other than it is determined in the related guidelines, allowing propagation of explosion to occur. Also, it was found that building constructions were not compatible with the recommendations by the Department of Defense guidelines.

- A process hazard analysis was only conducted on one activity. Process hazard analysis should be conducted for all dangerous activities on site. Moreover, workers were not involved in the hazard identification. Had they been, they may have pointed out additional dangerous activities that should be subject to the PHA.

- It is particularly important that high risk sites also employ appropriate technical measures to counter safety management system weaknesses. Appropriate separation distances between buildings are a standard technical measure to mitigate explosive risk. Having a protective building structure in place that complies with regulations could also prevent further injuries in case of an accident.
