**COMMISSION
ON PROCESS SAFETY**

Committee report

Experience Reports:

Evaluation of the Reports on

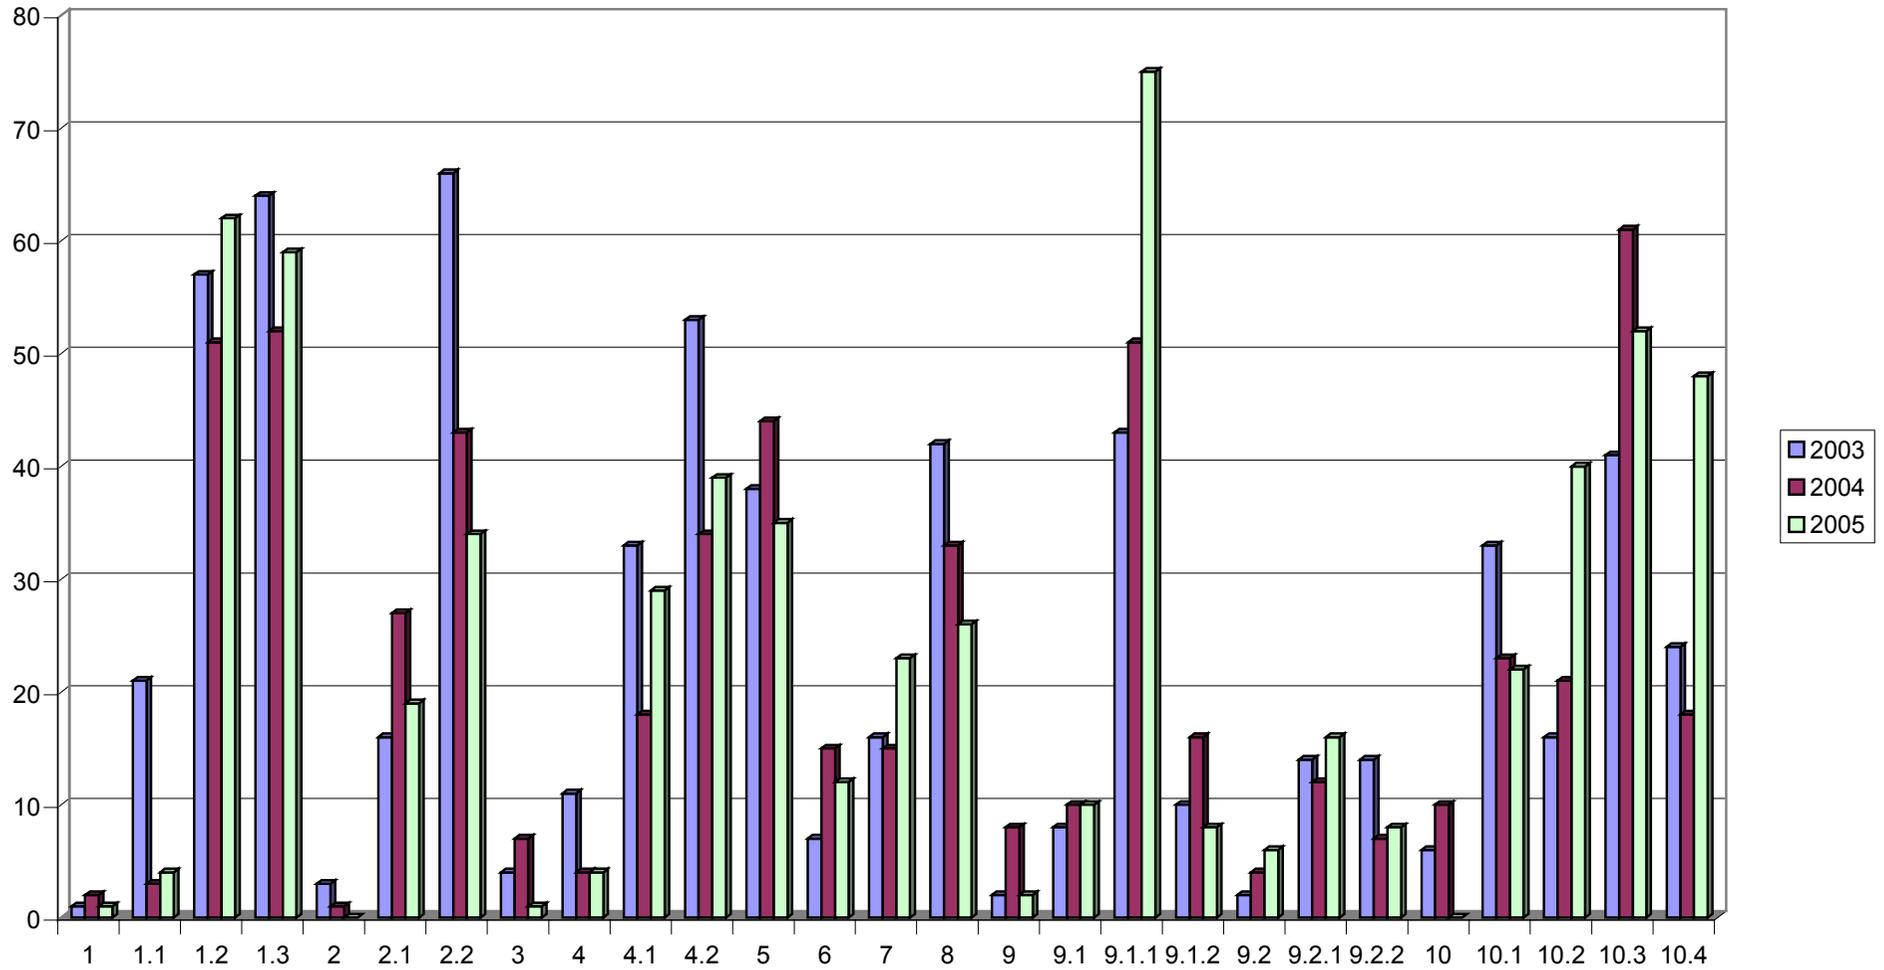
Attribution of deficits to failure codes for the years 2003 - 2005

In summary, the main areas where shortcomings were detected (see next page) were widely the same as in the experience reports for the years 1999 to 2003, with significant deficits in the areas of explosion protection, (constructional) fire protection, process control engineering, process engineering design and organisation. In the years 2004 and 2005, inadequate testing and deficits in system analysis were further frequently noted problems.
