Lessons Learned Bulletin No. 5 CHEMICAL ACCIDENT PREVENTION & PREPAREDNESS

Major accidents involving fertilizers

Number 5
June 2014

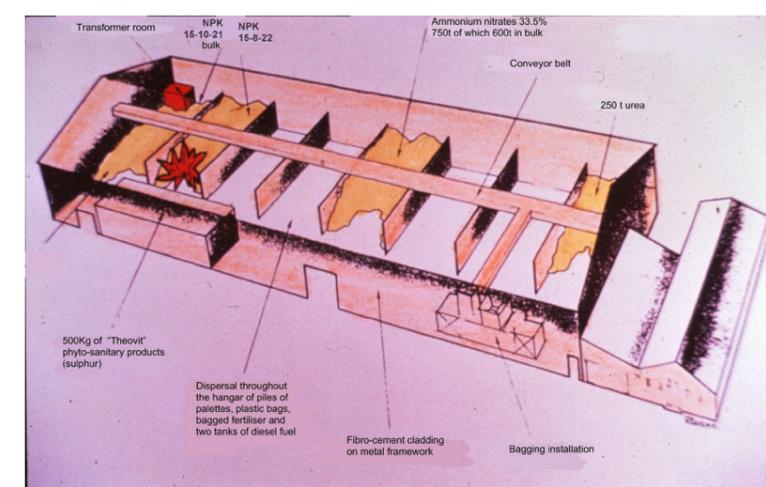
Figure 1: The installation concerned Source: ARIA N° 5009

- Local authorities should be aware of the dangers associated with ammonium nitrate hazards and oversee the sites in their jurisdiction as appropriate to the level of risk. Even sites with relatively small quantities can be significant risks if they are in close proximity to human development (See Figure 1).

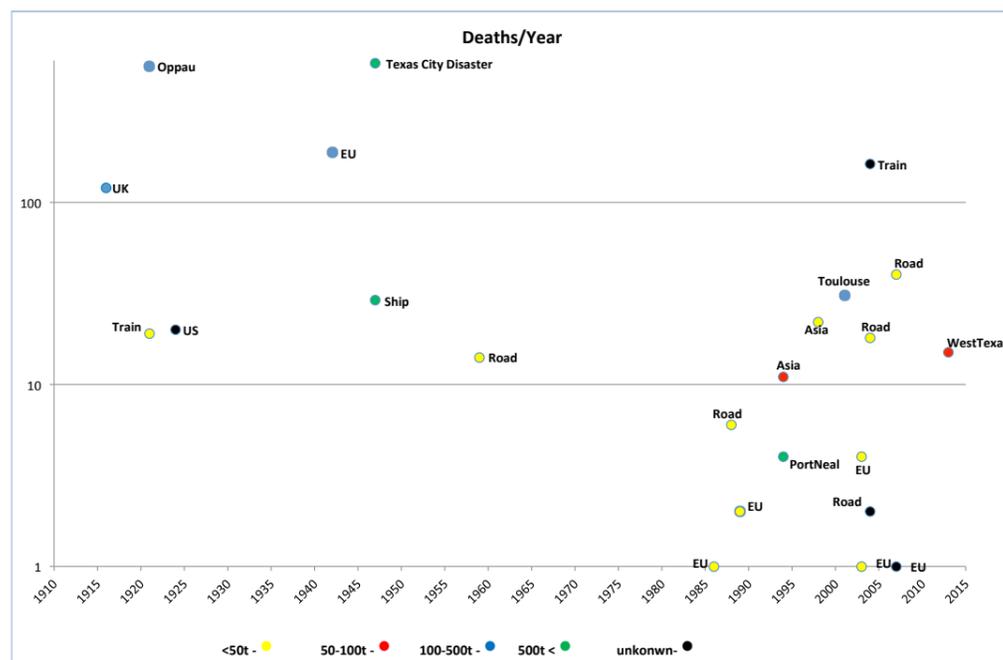
Figure 2 Fatalities and tonnage associated with AN accidents (Source: eMARS and http://en.wikipedia.org/wiki/Ammonium_nitrate_disasters.) If you would like a list of the accidents in this chart and references used, please send an email with your request to emars@jrc.ec.europa.eu.

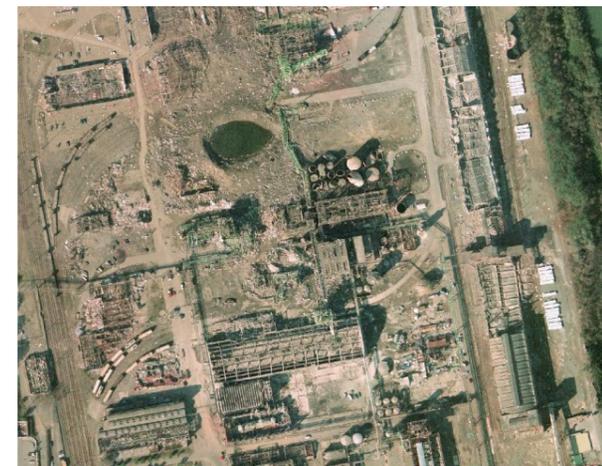
Figure 3: The area affected by the explosion (Source:©Archives Grande Paroisse)

At 10.17 a.m. on 21 September 2001 a severe explosion occurred in Shed 221, a temporary storage of downgraded ammonium nitrates at the AZF industrial site in Toulouse, France. The detonation, felt several kilometers away, corresponded to a magnitude of 3.4 on the Richter scale. Significant dust fallout from the installations and a 7 m deep crater (65x45m) were observed outside the plant. A large cloud of dust from the detonation and red smoke drifted to the north-west. The appearance of the smoke is linked to the emergency shutdown of the nitric acid manufacturing installation. Before rapidly dissipating, the cloud containing ammonia and nitrogen oxides sickened witnesses who complained of eye and throat irritations. The atmospheric pollutants released after the detonation lead to the formation of nitric acid (HNO₃), ammonia (NH₃), nitrogen dioxide (NO₂) and nitrous oxide (N₂O) from ammonium nitrate. As a precautionary measure, the local governmental authority ("Préfecture") requested that the population of Toulouse confine themselves to their homes, however, windows were broken. The accident resulted in 31 casualties (22 on site and 9 off site), 30 people were seriously injured and 300 people were hospitalized. In addition, 2500 people received hospital treatment.

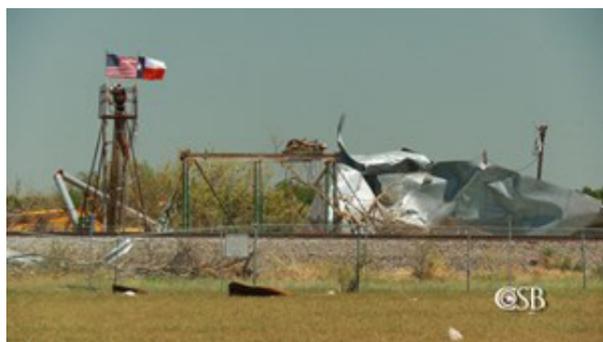
Figure 4: The scene following the accident (Source – U.S. Chemical Safety Board)

On the evening of April 17, a fire of undetermined origin broke out at the West Fertilizer Company Storage and distribution facility in West, Texas (USA). The facility had already closed for the day and was unattended. Firefighters found the warehouse building in flames and were in the process of extending hoses to fight the fire, and were applying some water to the blaze. Although the firefighters were aware of the hazard from the tanks of anhydrous ammonia as a result of previous releases, they were not informed of the explosion hazard from the approximately 60 tonnes of fertilizer grade ammonium nitrate inside the warehouse. While firefighters were positioned nearby, the ammonium nitrate suddenly detonated. A shock wave, traveling faster than the speed of sound, crushed buildings, flattened walls, and shattered windows. Innumerable projectiles of steel, wood, and concrete – some weighing hundreds of pounds – were hurled into neighborhoods. Twelve firefighters and emergency responders were killed along with at least two members of the public. More than 200 were injured and more than 150 buildings were damaged or destroyed. If this incident had occurred earlier in the day, many more people might have been killed or injured.
