Lessons Learned Bulletin No. 8

Major accidents involving explosives

Number 8
December 2015
JRC99808

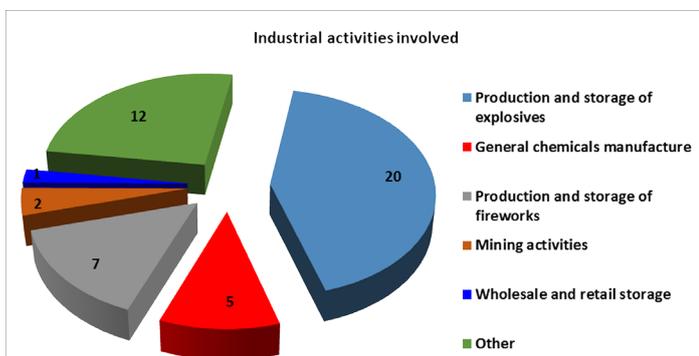
Accidents involving explosives are still occurring with a regular tendency, with two to four events a year almost every year since 2000. In the last five years alone, there were twenty major accidents in Europe involving explosive substances¹. Many of the events studied also appear to be repeat accidents, that is, the same accident occurred more than once within the same facility over a number of years (e.g., EMARS Accidents #729 and #1031; EMARS Accidents #276 and #918; ARIA No. 32086 and No. 45545). This recurrence is a strong indication that many sites are still failing to learn from past accidents.

Figure 4: Number of major accidents involving explosives (Source: eMARS)
